AquaBlok®

Installation Summary

Objective: Basin Rehabilitation/Anti-Seep

Location: Napoleon, Ohio

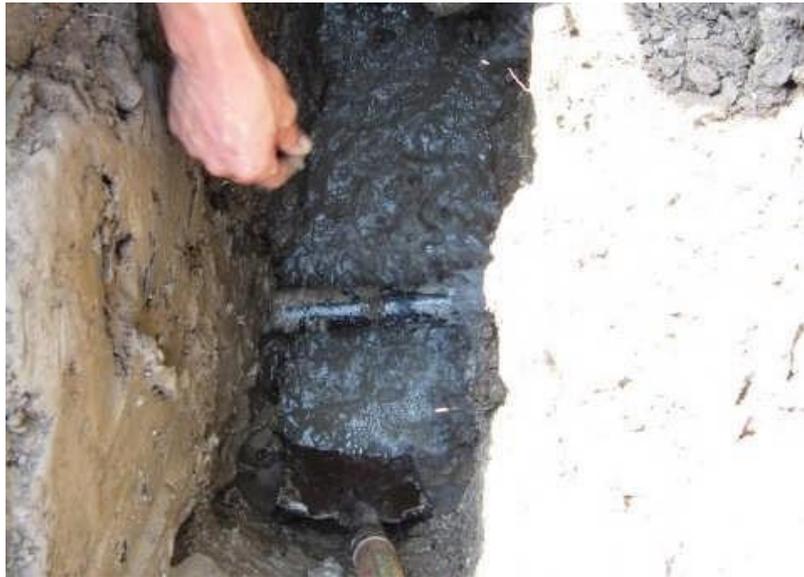
Photo 1. Significant water flow/leakage due to piping around a PVC line associated with a geothermal loop system adjacent to a residential pond (basin 6' to left; residence 50' to right)

AquaBlok Solution: Two cubic yards (2 bulk bags or 4,800-lbs) of AquaBlok® 2080FW#8 (PONDSEAL™) were placed to fully encircle the two 2"-diameter PVC pipes and to fill the trench that extended approximately 6' in either direction of the pipes. The overall trench dimension was approximately 12'L x 4.5'D x 1'W. Product was added to the trench without drawdown to the pond. Water entering the trench was not problematic. In fact, it served to hydrate the newly applied AquaBlok and jump-start the seal.

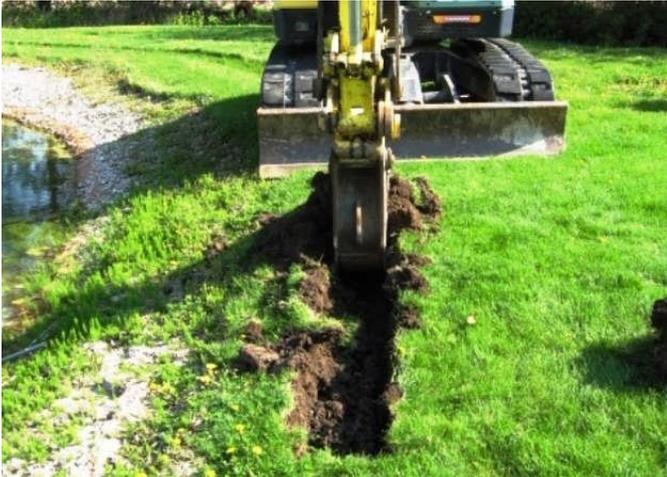
Photo 2. Trench excavation directly adjacent to the pond (left) starting at the top of the berm. Geothermal lines (2" diameter PVC) lie ~3' beneath bucket, running perpendicular to trench

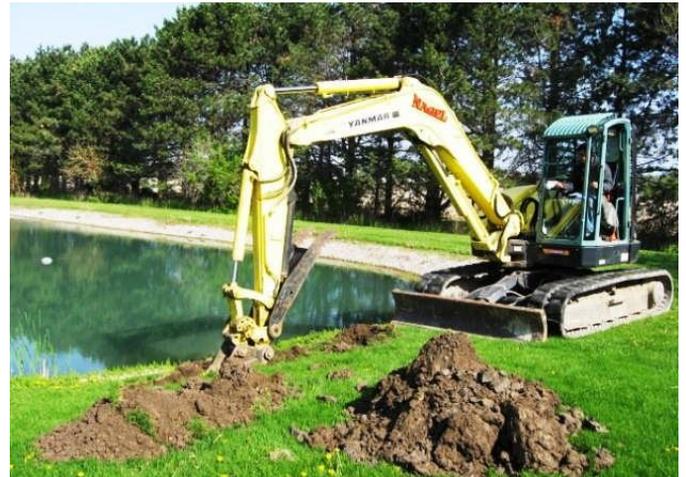
Photo 3. Compact excavator with 12" bucket continues excavation of trench. The overall trench dimension was approximately 12'L x 4.5'D x 1'W

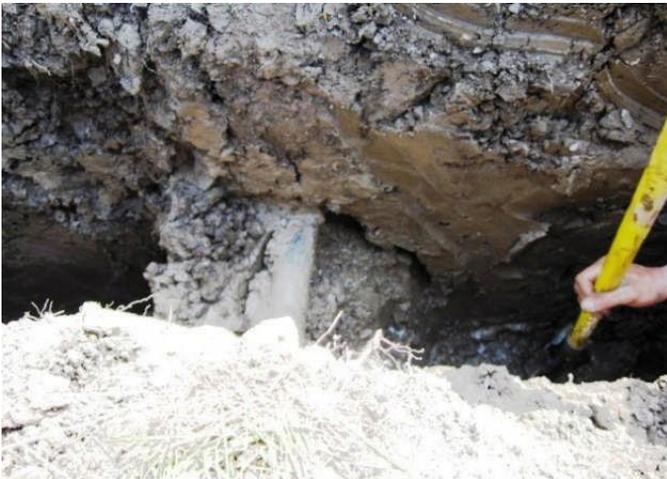
Photo 4. Evidence of subsidence associated with piping around the exterior of the pipe. Note highly plastic properties of surrounding clay

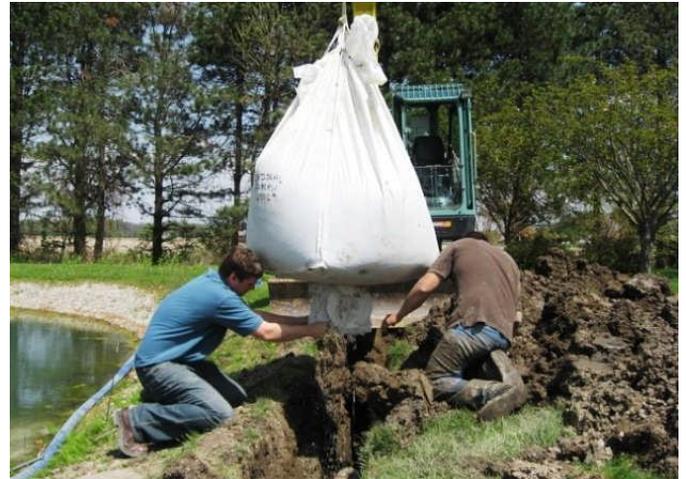
Photo 5. A 2,400lb (1 cubic yard) bulk bag of AquaBlok suspended by lifting straps from the excavator

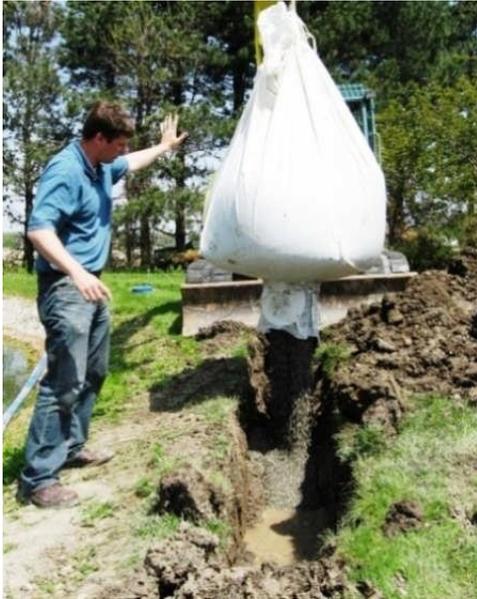
Photo 6. AquaBlok placement from the bulk bag via the discharge snout – note the water in the trench

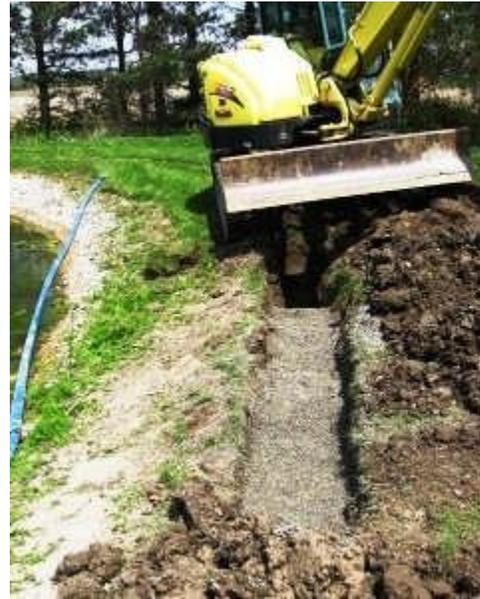
Photo 7. AquaBlok in trench just prior to placement of surface topsoil/sod
