# AquaBlok® Installation Profile

Greenville Municipal Landfill, Greenville, Ohio **Project Status:** Completed January 2008

**Setting / Purpose:** Freshwater Creek – Control of Cap/Bank Erosion on Closed Landfill

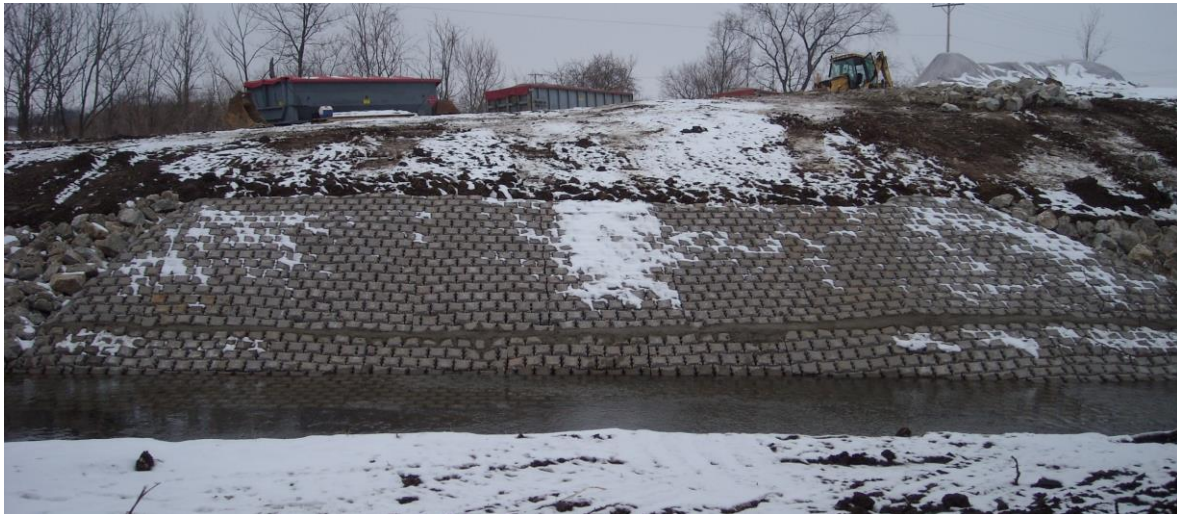
Overview of Completed Slope Repair/Stabilization with AquaBlok Landfill Cap Seal / Repair

**Contaminant(s) of Concern:** Creek bed erosion penetrated historic landfill cap and was causing a release of leachate from landfill into creek. AquaBlok, a bentonite coated aggregate sealant, was selected to provide the low permeability (in the range of  $10^{-9}$  cm/sec) interface with the existing landfill cap.

A multi-layer design was used to first re-establish the landfill cap, then to provide bank/slope protection to high flow conditions in the creek bed. The first layer utilized a 6" thick Geocell to maintain the AquaBlok capping/sealant material on the slope of the creek. This was then covered in a geofabric and a layer of stone. An articulated concrete mat was placed over the entire area to provide the final level of protection from long-term erosion to the bank. Site area was comprised of 3,000 square feet of embankment area.

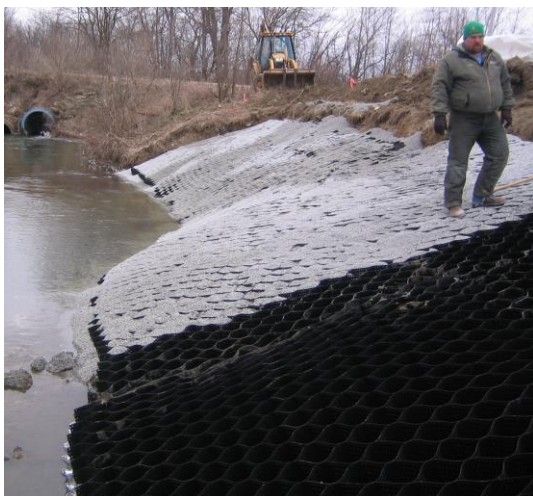
Overview of AquaBlok in Geocell on Slope

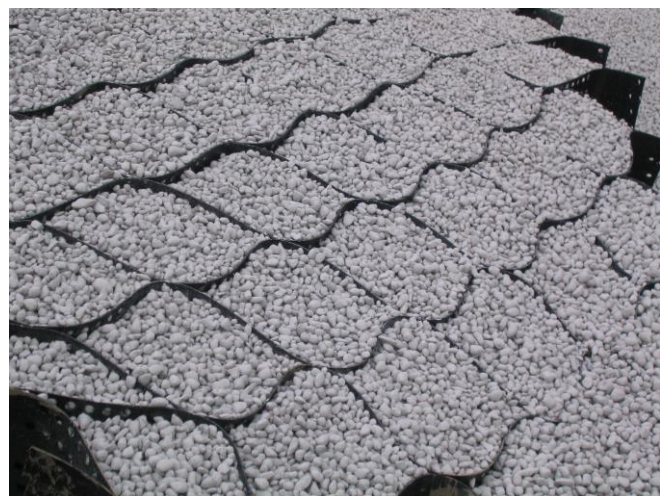
Close-up View of AquaBlok in Geocell
