AquaBlok®

Installation Summary

Objective: Anti-Seep Collar/Berm Stability
Location: West Norriton, Pennsylvania
Setting: Retention/Detention Basin
Project Status: Completed June 2011

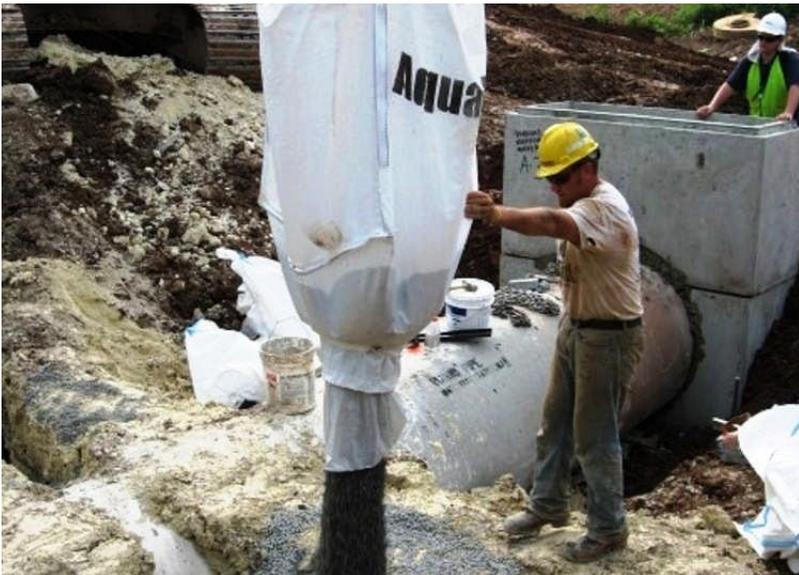
Photo 1. AquaBlok placement from a bulk bag (standard shipping unit for bulk material) using a track loader/excavator – note discharge snout directing product into trench cut perpendicular to the overflow discharge pipe

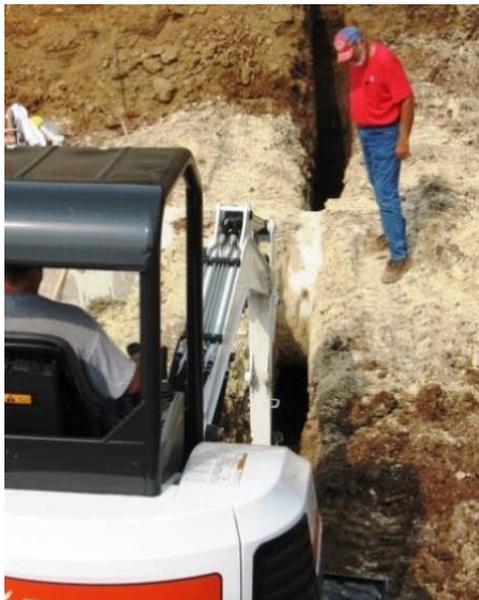
Photo 4. Overview of perpendicular trench showing intersection with 36" diameter steel reinforced, Class III concrete overflow discharge pipe

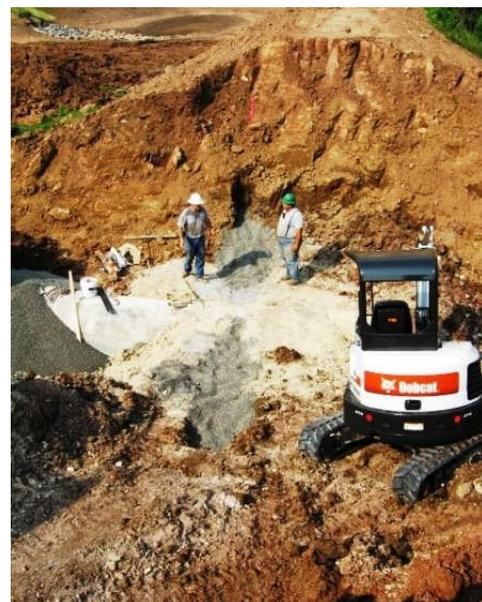
Photo 5. AquaBlok filled anti-seep trench from atop existing berm (lift one of three, ~6 vertical feet of the ~18 vertical feet total)

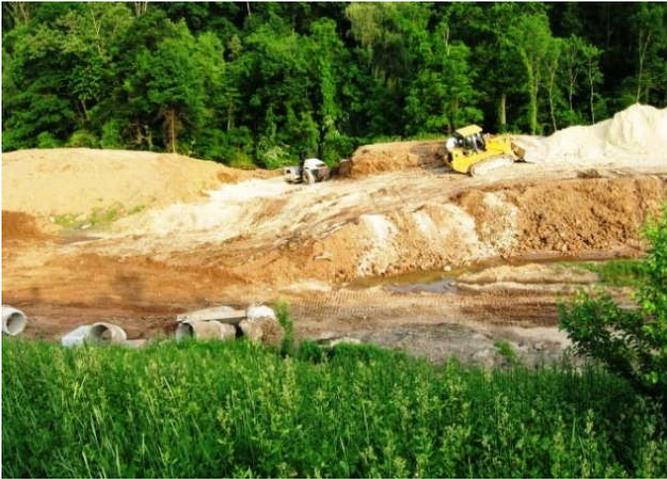
Photo 6. Berm reconstruction in process (basin in foreground)

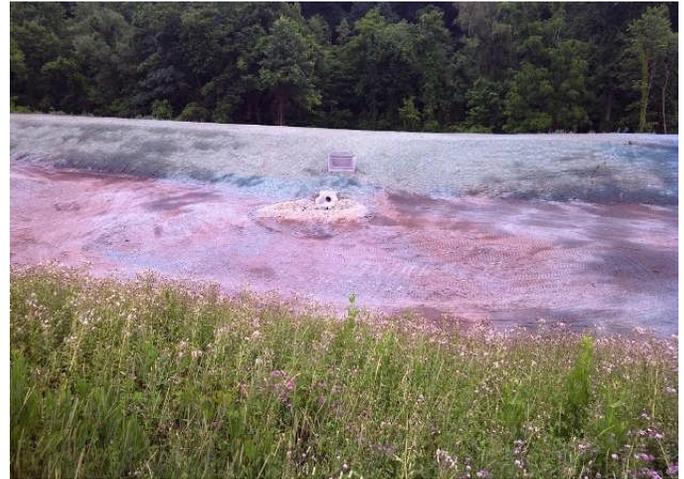
Photo 7. Berm reconstruction completed (basin in foreground) - note riser structure in center of photo
