AquaBlok® Installation Profile

Chattanooga Creek, Tributary of Tennessee River, Chattanooga, TN

Project Status: Two Phase Installation - Completed Fall 2007

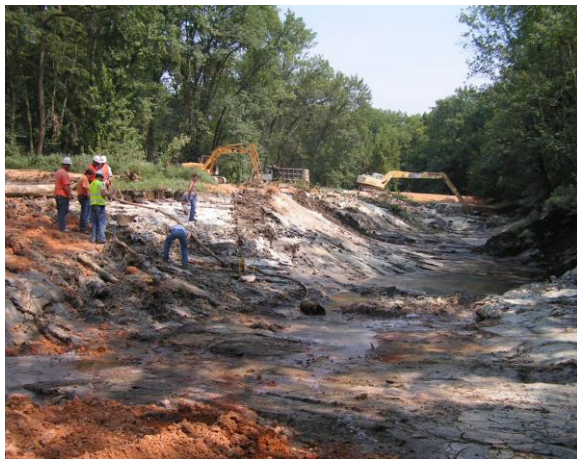
Photo 1 – Prior Excavation of Creek Bed

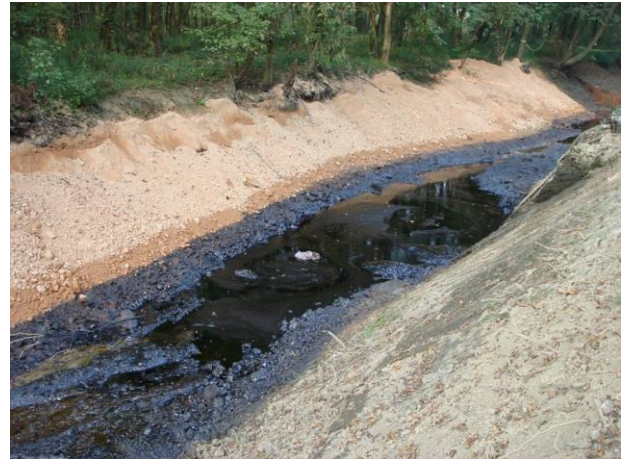
Contaminant(s) of Concern: DNAPL - PAHs (polynuclear aromatic hydrocarbons). Creek bed was experiencing seepage of hydrocarbon-based contaminants.

Photo 2 – DNAPL Seepage in Creek Bed

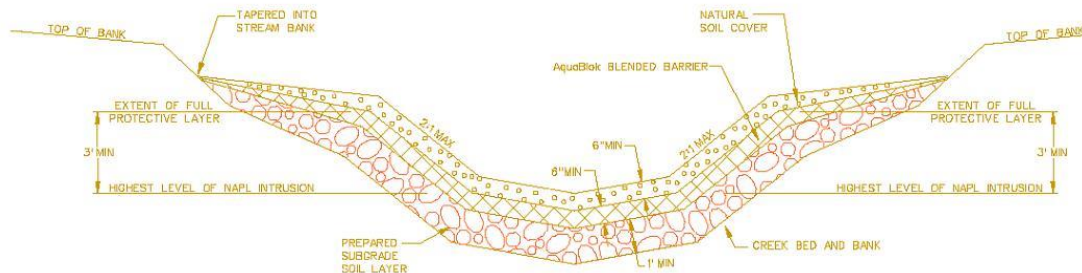
AquaBlok Cap Design / Site Area: Layer of 3070FW Blended Barrier product was applied in 8” thickness in prepared creek bed and hydrated. A 6” layer of native soil was applied over the cap. Site area was comprised of a 2,000-foot segment of the creek which included an oxbow, for a total of over 175,000 SF.

TYPICAL MODIFIED RESTORATION CHANNEL CROSS-SECTION
NOT TO SCALE

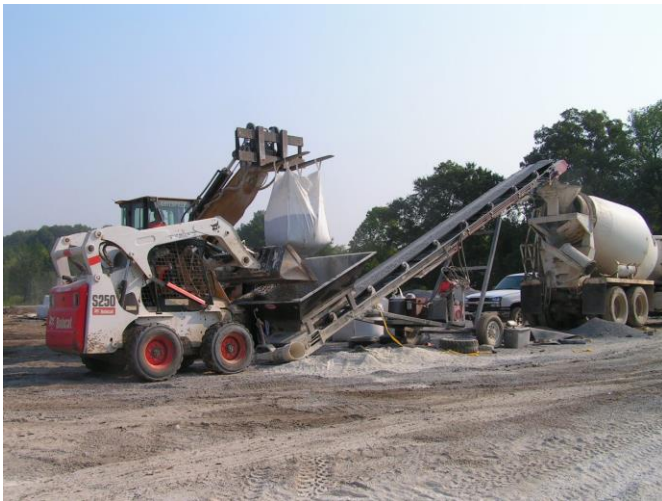
AquaBlok Installation: AquaBlok 3070FW #8 material was shipped to the project site in bulk bags on flat bed trucks and stored on site. The AquaBlok was blended with locally sourced aggregate on site in conventional mixer trucks and driven to the creek. Long stick excavators placed the material directly onto the creek bed. Stakes were placed for thickness measurement, but minimal labor was required for the actual placement.

Photo 3 – Preparation of AquaBlok Blended Barrier

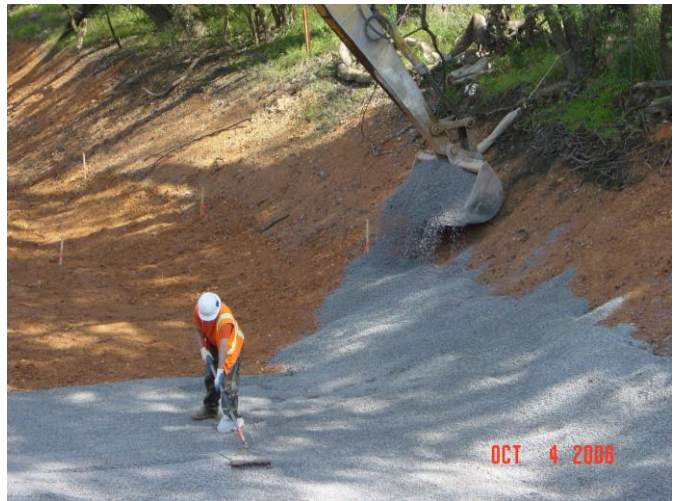
Photo 4 – Application of AquaBlok to Creek Bed

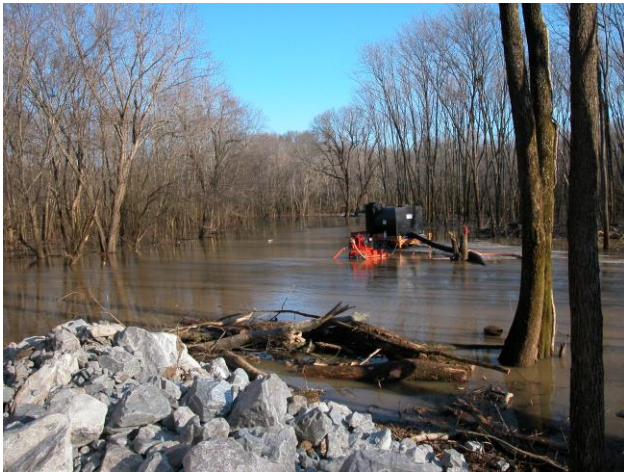
Site Related Challenges: The project site experienced a number of significant rainfall events over the course of the installation. During the Phase I installation, the site contractor was forced to abandon the site after the Tennessee Valley Authority released water upstream on the Tennessee River and caused the entire work area to become inundated from water moving upstream on the Chattanooga Creek. In addition, site pumps were overwhelmed on at least two occasions and the temporary dams on the creek were breached once.

Photo 5 – View of Total Flood Event

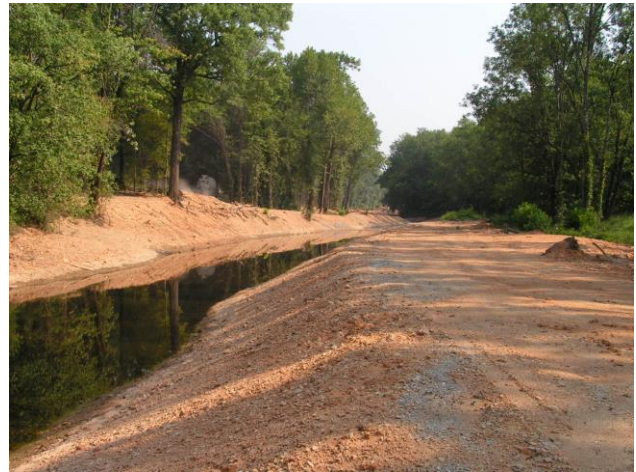
Photo 6 – Finished Creek Section After Flood Event

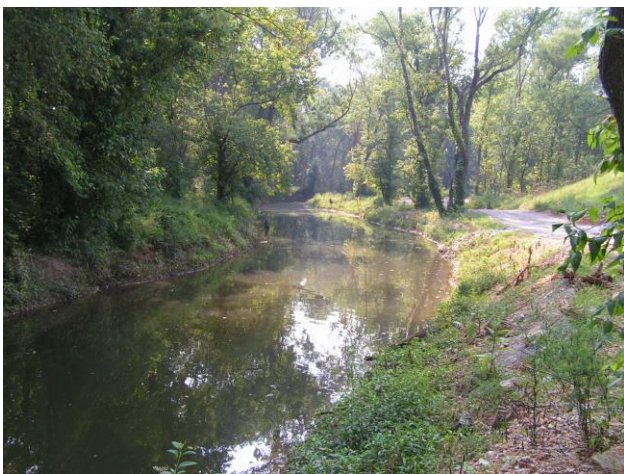
Photo 7 – A view of a section of the creek bed completed in fall of 2006. Photograph taken in August 2007 indicates a rapid recovery of natural stream habitat.

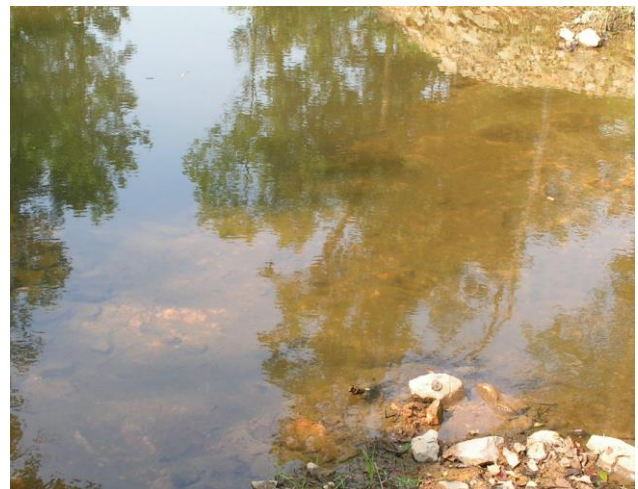
Photo 8 – A close up view of the AquaBlok in the completed section of the creek bed. The product was stained by the clay cover to resemble the natural stream bed.
