# AquaBlok® Installation Profile

**Site Location:** *US EPA Region 6*  
Arkansas River – Tulsa, OK

**Project Status:** Completed Fall of 2012

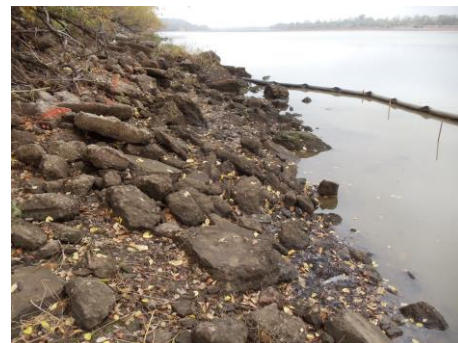
**Above – Demo Debris Area - Before**

Area A This segment consisted of approximately 1,200 feet of river bank with a steep slope (nearly 1 H :1 V) and a vertical drop from the crest of the slope to the river bank of approximately 30 feet. The river bank is heavily vegetated (estimated 30+ year old trees) and covered with demolition debris consisting of concrete, bricks, pipes, etc. In and amongst the demolition debris acid sludge has been observed in addition to river bank sheening. It was determined that Area A would receive a Horizontal Funnel & Gate capping system that consists of a permeable treatment system. No sub-base preparation would be performed, other than the removal of any woody debris, plants etc. from the shoreline capping area. Following this preparation, the AquaGate+Organoclay permeable treatment material would be placed along the base of the demo debris out into the river approximately 20 feet at an application rate of approximately 7 lb/SF directly over the existing sediment surface at a thickness of approximately 1 inches

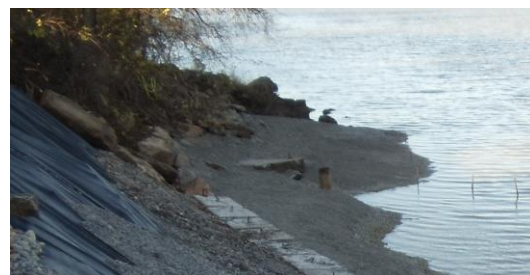
**Above – Demo Debris Area - After**

(+/- 0.5 inch). After placement of the permeable treatment layer, the low-permeability AquaBlok layer would be placed directly over the AquaGate+Organoclay with the material working back up the shoreline slope. Placement of the AquaBlok continued beyond the organoclay layer up over the existing demo debris. The application rate is estimated to be approximately 40 lb/SF to achieve a nominal 5 inch dry thickness (+/- 1.0 inch), which will swell when hydrated to achieve a final layer thickness greater than 6 inches.

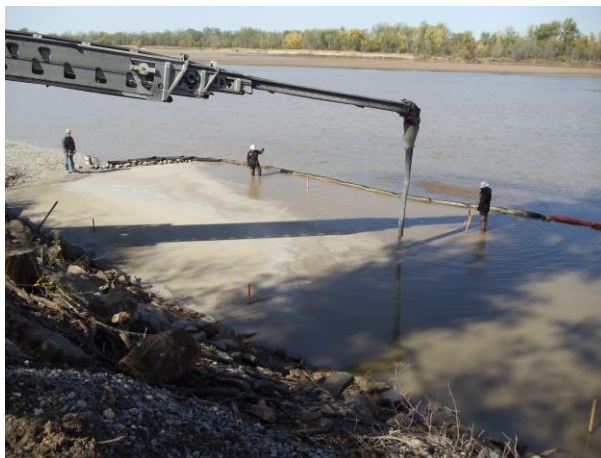
**Above – Placement of AquaGate+Organoclay**

It was determined that Area B would receive a Horizontal Funnel & Gate capping system of essentially the same construction as Area A above. No sub-base preparation would be performed. AquaGate+Organoclay permeable treatment material was placed along the base of the rip rap zone out into the river approximately 50 feet at an application rate of approximately 7 lb/SF directly over the existing sediment surface at a thickness of approximately 1 inches (+/- 0.5 inch). After placement of the AquaGate, a low-permeability AquaBlok layer was placed directly over the AquaGate with the material working back up the shoreline slope. The application rate is estimated to be approximately 40 lb/SF to achieve a nominal 5 inch dry thickness (+/- 1.0 inch), which will swell when hydrated to achieve a final layer thickness greater than 6 inches.

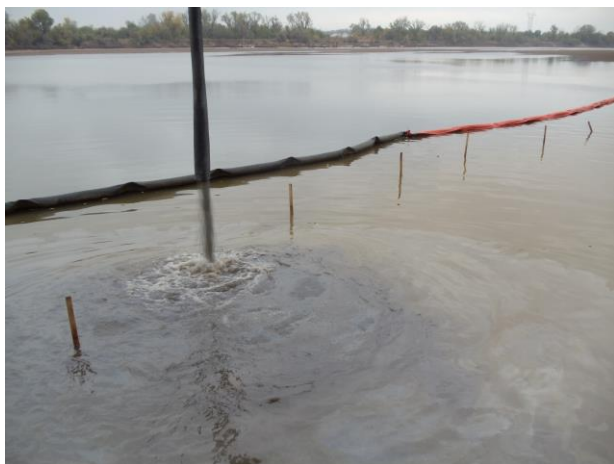
**Above – Close-up of Telebelt Material Placement**

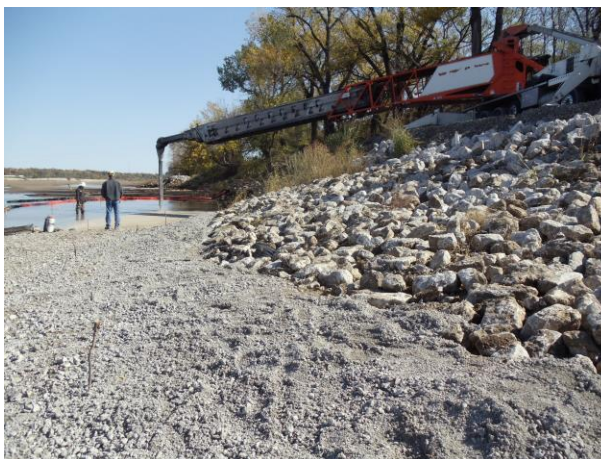
**Above – View of Telebelt During Armor Stone Placement**

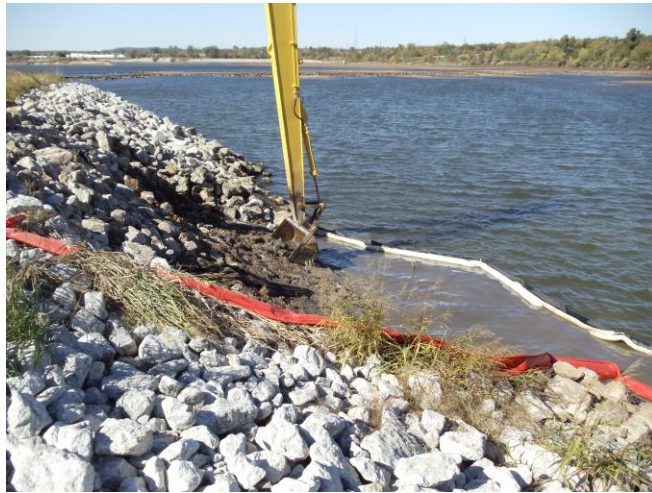
Left – Placement of AquaBlok Over Rip Rap  
Below – Using Blower to Distribute AquaBlok

Area C Rip Rap & LNAPL: Approximately 4-5 years ago a remediation project was completed in this area that included a river bank improvement (installation of clay, geotextile, and nominal 12-18 inch rip rap) along approximately 1,300 lineal feet of river bank. It has been determined that this approach failed as the result of observed sheening along a portion of the river bank. Sheening was observed at the toe of the slope and also emanating from the river bed sand approximately 10-20 feet beyond the toe of the slope. Some sheening was observed on the slope amongst the rip rap. This area is open and easily accessible, so it was determined that two approaches would be employed at this location. First, a layer of rip rap was Photo 1 – Prior Removal of Rip Rap removed and a layer of low permeability AquaBlok was placed along the slope of the shoreline as a means to cut-off seepage through the GCL and existing rip rap. Secondly, an attempt was made to place AquaBlok directly over and between the openings in the rip rap to determine if it would be possible to provide a low permeability barrier to prevent seepage without removal of the rip rap.
