AquaBlok®

Installation Summary

Objective: Basin Rehabilitation

Location: Findlay, Ohio

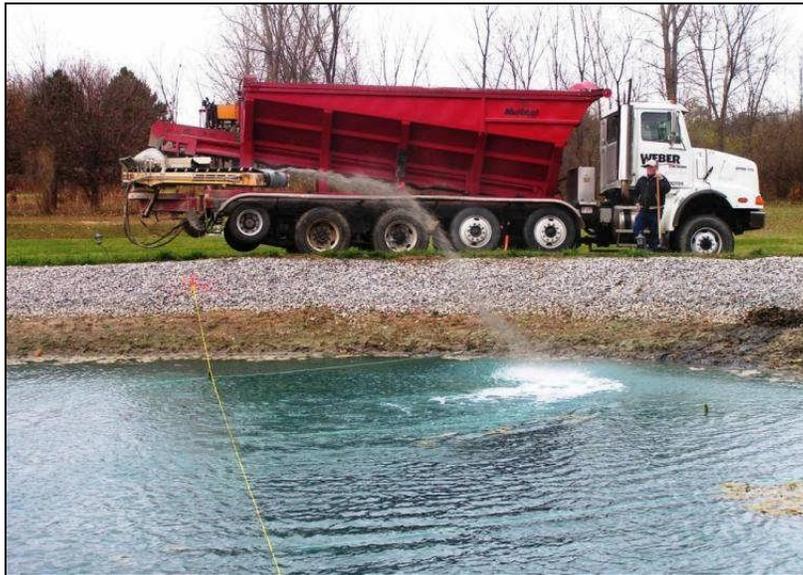
Photo 1. AquaBlok placement from a stone slinger truck through up to 8 feet of water to reinforce basin substrates and reduce losses associated with the permeable earthen basin. Note guide ropes to aid in uniformity of coverage

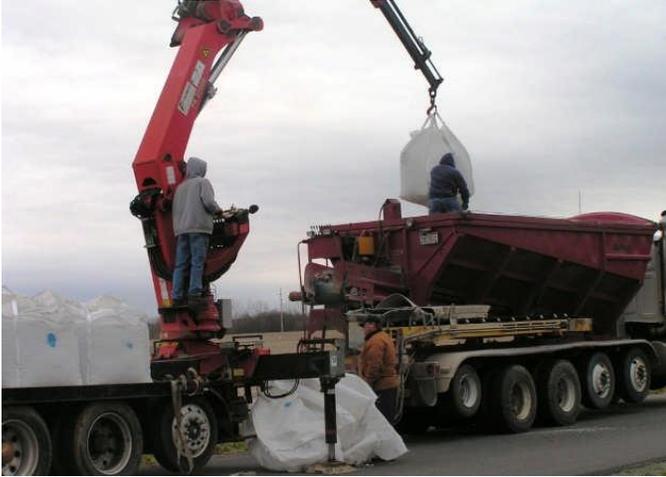
Photo 2. Transloading AquaBlok from a 2,400lb bulk bag (standard shipping unit) to the bed/hopper of the application equipment - a stone slinger

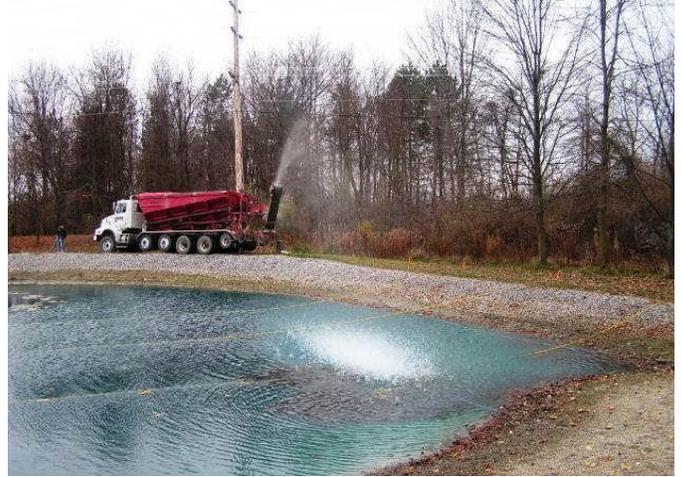
Photo 3. AquaBlok placement from a shore-based stone slinger truck. Note rope dividing the basin to assist in uniform product coverage (each 17'x17' unit received 1 ton of product)

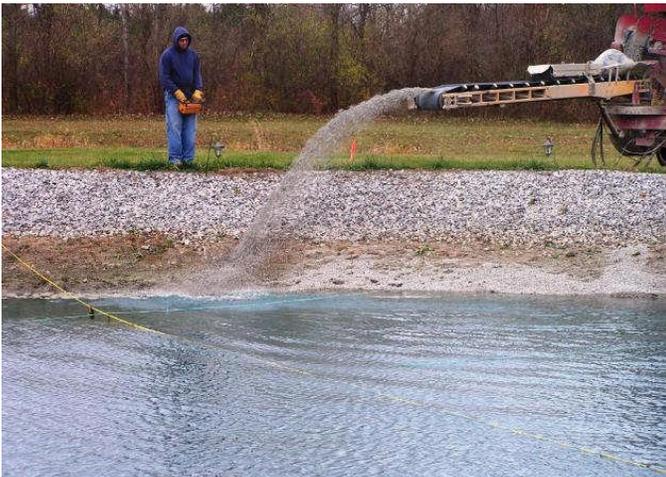
Photo 4. Shore-based stone slinger truck being controlled by operator. Note application up side slopes to transition between basin floor and rip-rap erosion protection

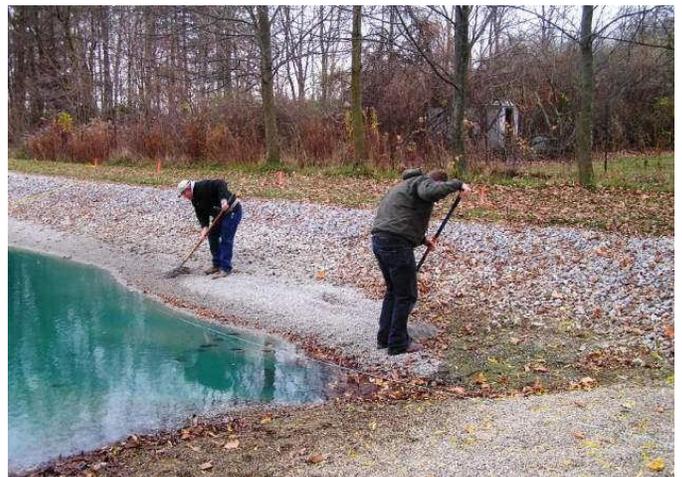
Photo 5. Leveling of dry AquaBlok on the shoreline, easily achieved using a concrete float or steel rake

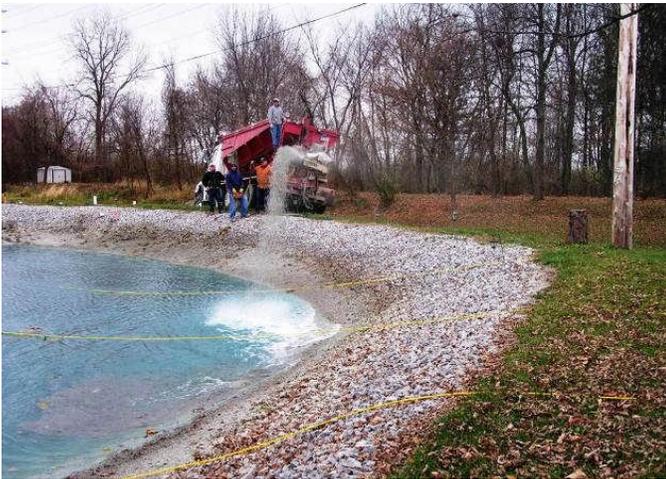
Photo 6. AquaBlok placement from a shore-based stone slinger truck (maximum reach typically ~75' from back of truck)

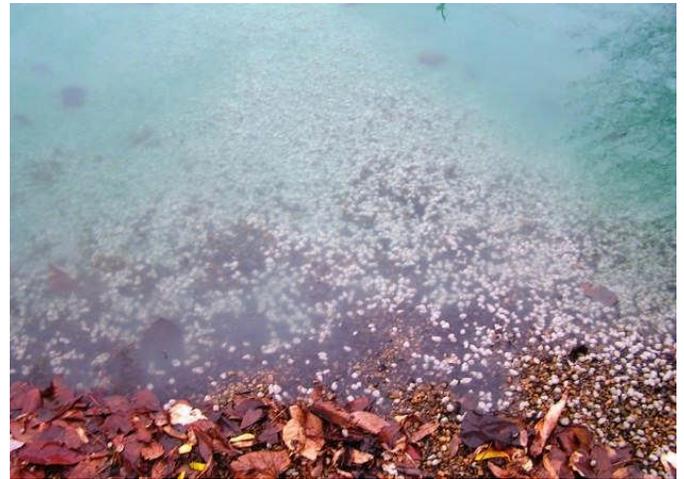
Photo 7. Individual AquaBlok particles minutes after application/inundation. Note additional product was ultimately placed in the foreground (atop the thin layer of leaf debris)
