# AquaBlok®

## Installation Summary

**Objective:** Tile Plug/Levee Rehabilitation

Location: Oak Harbor, Ohio

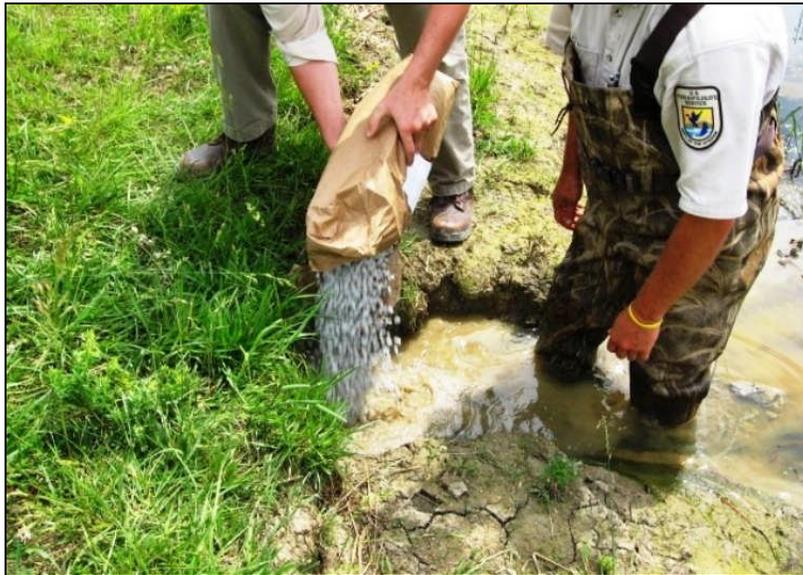
Photo 1. AquaBlok placement from a 50lb paper bag into a remnant agricultural field tile (flow from right to left through the earthen dike).

**AquaBlok Solution:** 250lbs (five, 50lb bags) of AquaBlok® 2080FW#8 (PONDSEAL™) were hand-placed into the upstream side of the remnant tile cavity. Because the material self-seals when hydrated, no mechanical compaction was needed. However, material was pushed by hand into the void until no more product could be added. Care was taken to remove any loose soil surrounding the opening so that the AquaBlok could “key” into stable substrate.

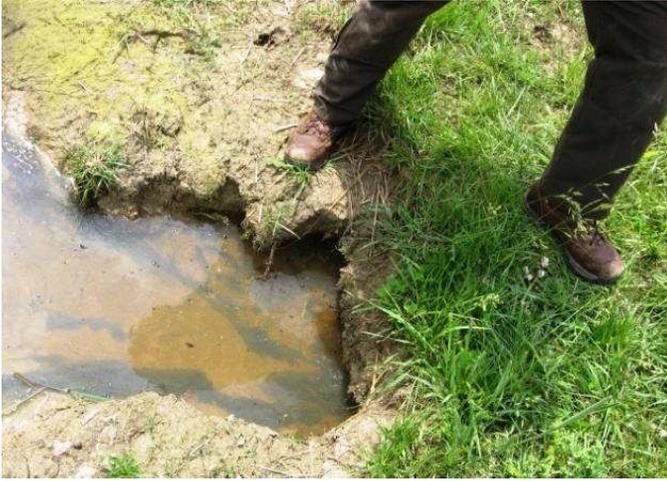
Photo 2. A top-down perspective of the breach in the earthen berm separating an inundated wetland (left) from an adjacent non-inundated wet prairie environment at drawdown (right).

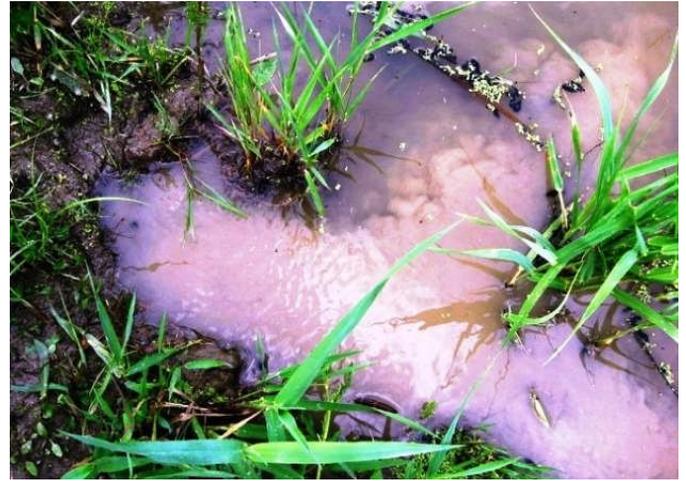
Photo 3. A top-down perspective of the water upwelling on the “back side” of the earthen berm – in the environment which was intended to be moist (not inundated).

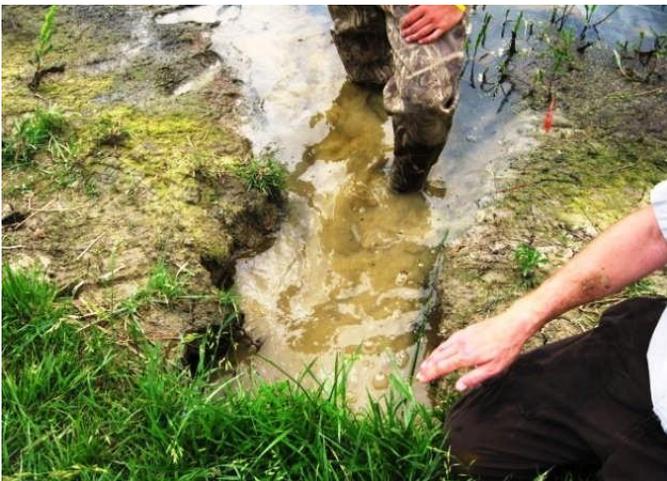
Photo 4. After closer inspection, the pathway (which measured exactly 24” wide) was determined to be the result of an improperly re-compacted trench dug to remove a remnant field tile.

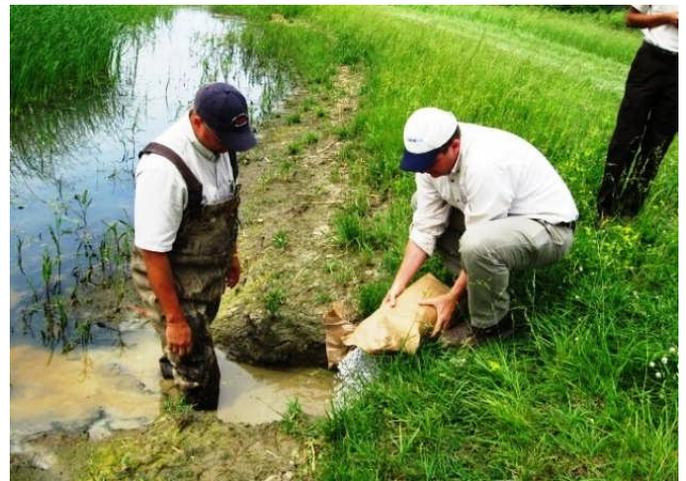
Photo 5. Manual addition of AquaBlok from a 50lb bag.

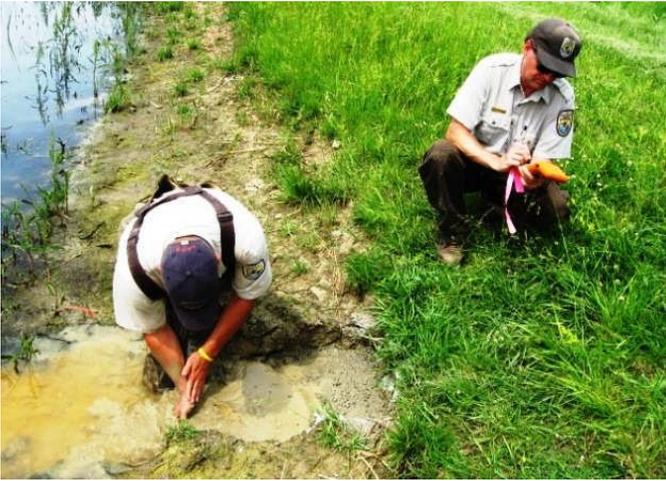
Photo 6. Active hydration of AquaBlok (five bags of 250lbs total) following product placement. Note technician marking location with GPS to track performance through time.

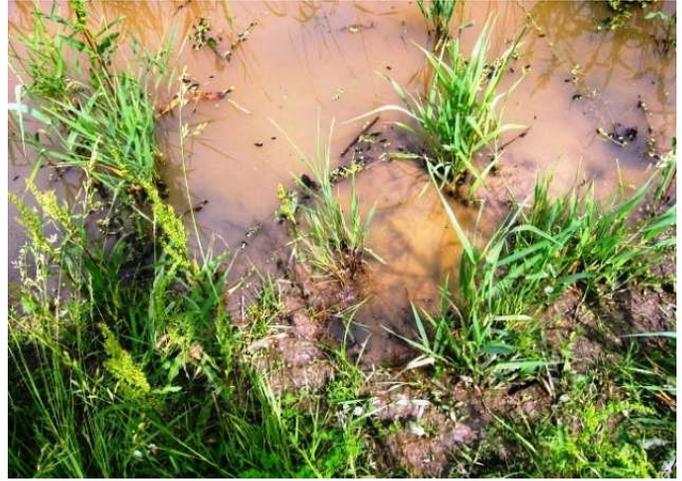
Photo 7. A comparable perspective to Photo 3 approximately 20 minutes after the placement of AquaBlok demonstrating the lack of upwelling (i.e. water loss) into the adjacent moist wetland unit.

**Results:** A visual reduction in flow through the berm could be observed almost immediately. The flow slowed even more over the ~1 hour that field personnel remained on the berm. By the following morning (20 hours post-application), there was no sign of water flow. The low lying area where water once passed through the berm (Photos 3 and 7) ultimately dried and has been observed only to be moist during subsequent visits to the site. The plug has remained stable an effective through time.
