AquaBlok®

Installation Summary

Objective: Basin Rehabilitation

Location: Columbus, Ohio

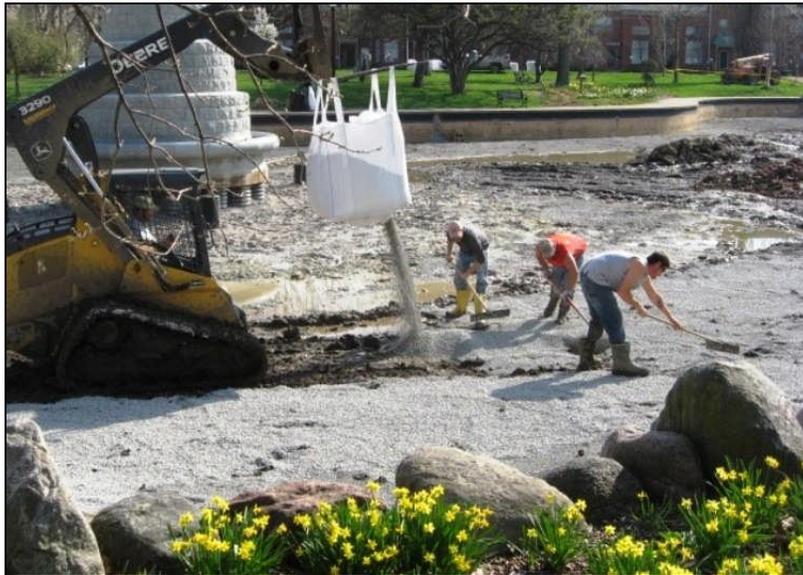
Photo 1. AquaBlok placement from a bulk bag (standard shipping unit for bulk material) using a track loader and steel rakes to level of "float" material and promote uniform coverage at 10lbs/SF

AquaBlok Solution: AquaBlok® 2080FW#8 (PONDSEAL™) was utilized to seal the entire basin floor and to provide extra insurance around the newly installed stone fountain. The dry bentonite-coated aggregate was broadcast at 10lbs/SF (1.5" nominal dry material thickness) over 37,750 square feet. Additional product was placed at the transition between the basin bottom and the vertical side walls and around the fountain and light caissons.

Equipment Used: Flatbeds for material delivery; long-reach forklift for material transloading from shipping units (2,700-lb bulk bags); remote operated stone slinger truck and track loader for dry material conveyance; manual labor (equipped with steel rake to float material and insure uniform coverage).

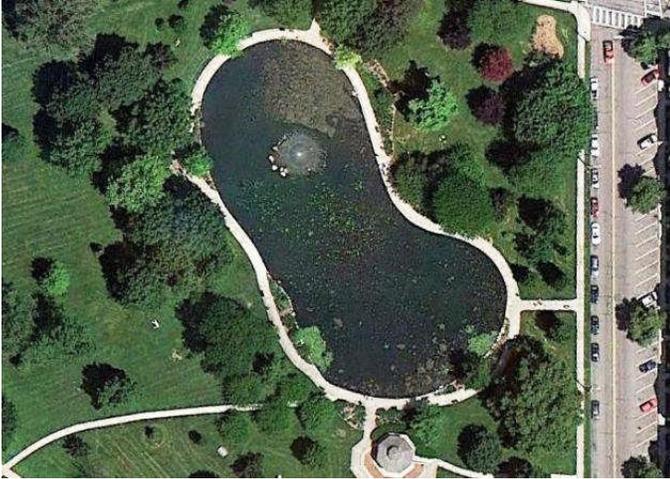
Photo 2. An aerial overview of the project site, Goodale Park (Columbus, OH), prior to drawdown and construction of the stone fountain (May 2010)

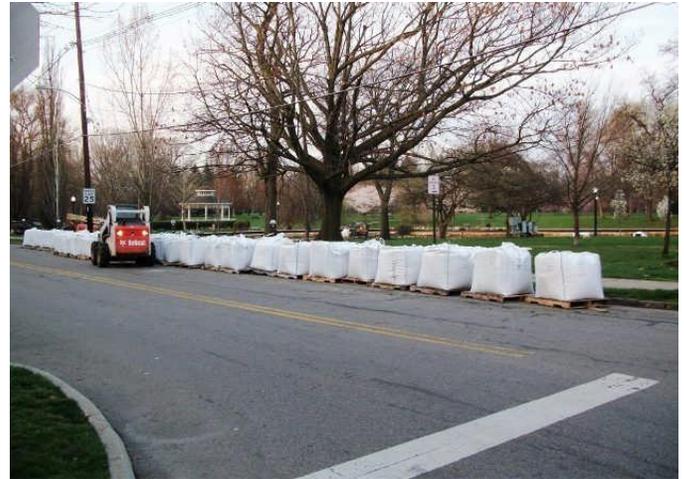
Photo 3. Bulk bags of AquaBlok being staged for application either by a slinger truck (see Photo 4) or track loader (see Photos 1 and 5) – standard shipping units 2,400-2,700lbs per bulk bag

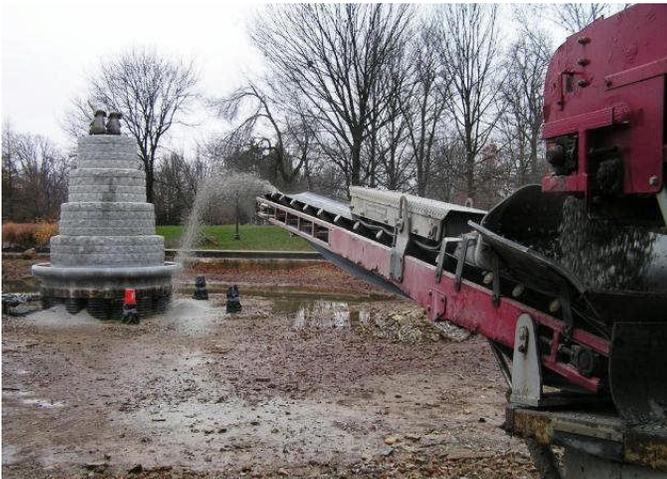
Photo 4. AquaBlok placement from a shore-based stone slinger truck to fortify the area directly adjacent to the newly installed fountain (maximum reach ~75' from back of truck)

Timeline: 20 tons of AquaBlok were delivered, transloaded into slinger truck, and placed around the fountain in one day (December 2011); the balance (190 tons) was delivered and applied using a track loader and manual labor over approximately one week (March 2012). One track loader with three laborers manually leveling material with rakes applied 14 to 15 tons per hour with the material staged directly adjacent to the basin.

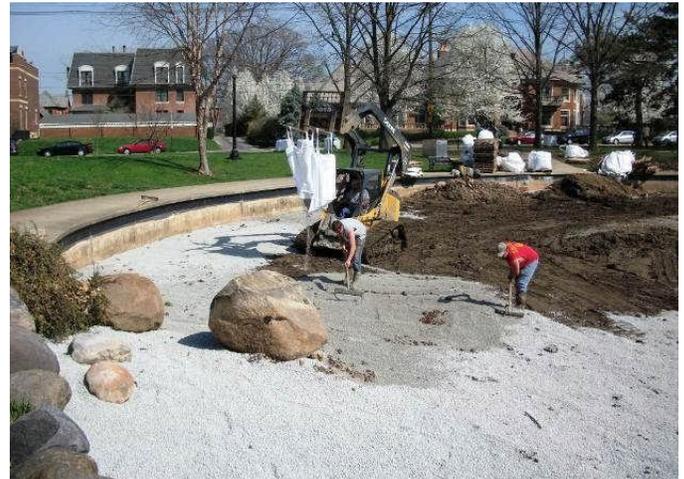
Photo 5. AquaBlok placement from shipping unit (reinforced nylon bulk bag) using a track loader and steel rakes to level or “float” material and promote uniform coverage at 10lbs/SF

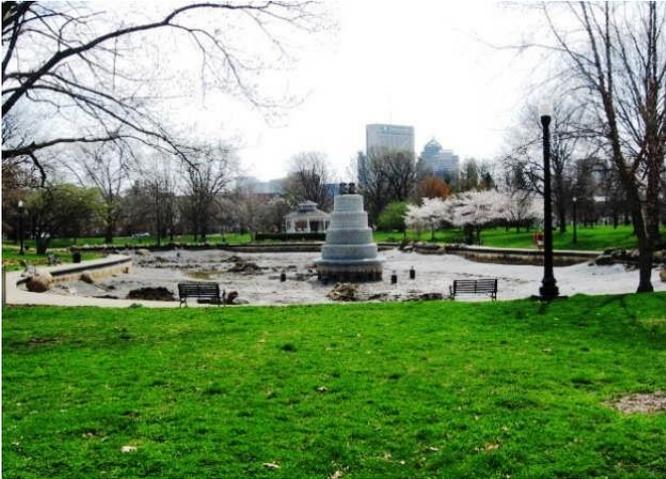
Photo 6. Basin overview immediately following completion of AquaBlok application (March 2012)

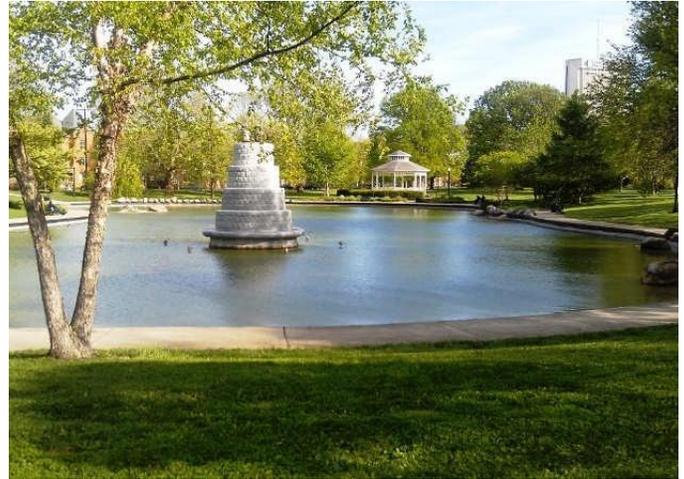
Photo 7. Basin overview following water addition (April 2012)

Results: The AquaBlok application, in conjunction with a roll-on sealant to the vertical side walls and a membrane apron around the perimeter of the fountain (bedded into AquaBlok) has reduced water losses from a maximum of twelve vertical inches per 24-hours to an average loss of approximately ½-inch per 24-hour period – a rate consistent with losses associated with evaporation.
