# AquaBlok®

## Installation Summary

**Objective:** Vertical Cut-Off Wall/Core Trench

**Location:** Tontogany, Ohio

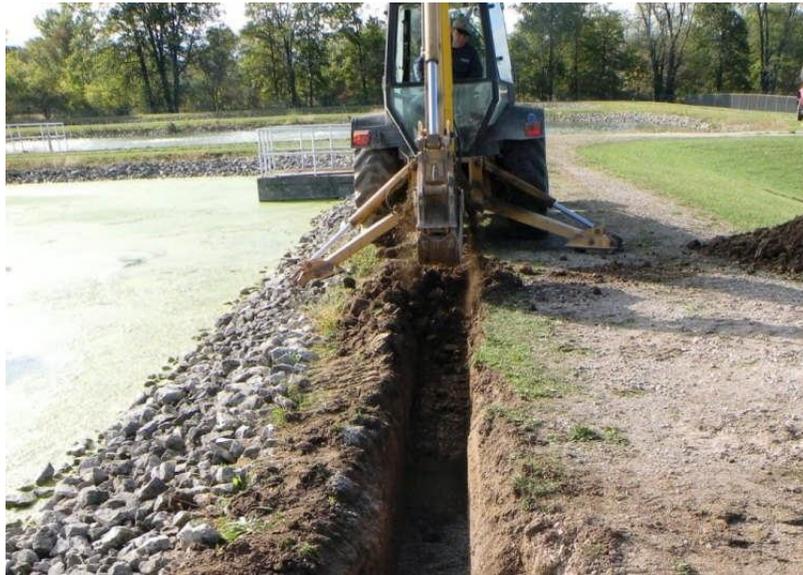
Photo 1. Loader/excavator cutting an 18" wide trench at the top of the berm adjacent to the leaking wastewater treatment pond (left). Note water in the basin during excavation

**AquaBlok Solution:** An 18"-wide trench was excavated to approximately 2' below the seep. The initial trench cut-off wall was excavated to a length of approximately 20', then backfilled with AquaBlok and partially hydrated using a garden hose – to help hold the material in place during subsequent trench excavations. Approximately 32 tons of AquaBlok was backfilled from the bottom of the trench excavation to approximately 2' below the surface of the berm (or ~18" above the designed high water elevation). The trench was subsequently extended in two additional lengths, resulting in an overall trench length of approximately 48'. The overall trench dimension was approximately 48'L x 10'D (average) x 1.5'W. Product was added to the trench without drawdown to the pond.

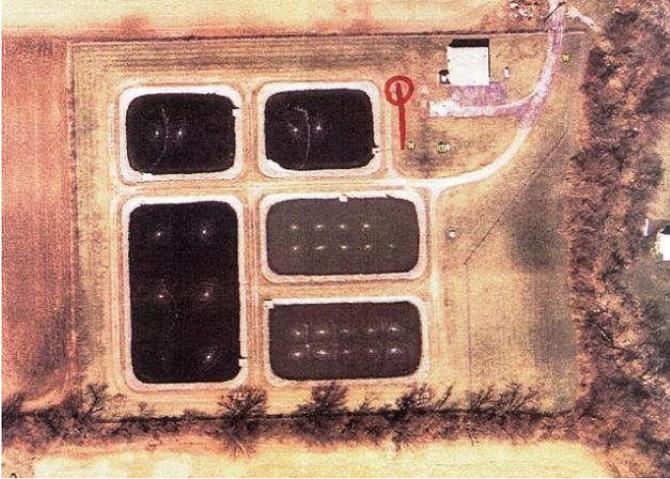
Photo 2. Aerial view of the project site showing the five treatment basins. Note approximate location of visible seepage denoted as a red line to the east of the northeastern-most basin.

**Background:** As the last in a five-basin wastewater treatment system, the settling pond on the northeast corner of the facility showed signs of sustained water loss through its eastern berm starting at its northeastern corner. Interior side slopes were steep enough (~2:1) that AquaBlok lining from inside the basin was not deemed feasible. Exploratory digging identified a defined inconsistency in substrate and visible seepage at a depth of 7.5 – 9.5' below grade. Therefore, the installation of a low-permeable core trench was determined to be the best remedy option.

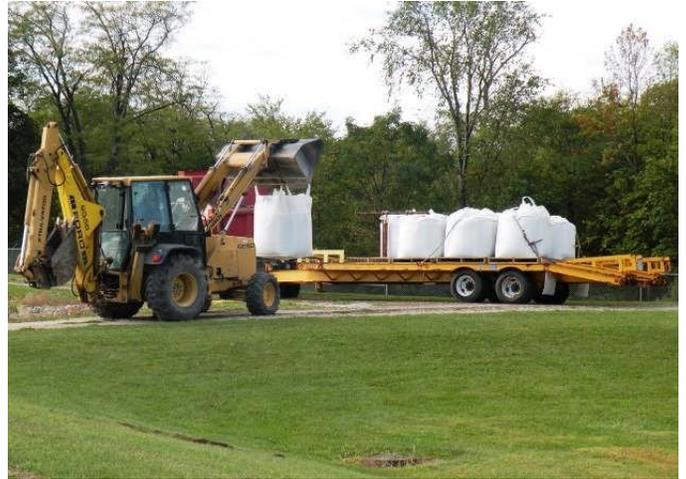
Photo 3. AquaBlok being off-loaded from the flatbed trailer in 3,000lb bulk bags (standard shipping unit for bulk material). Note four lifting straps at the corners of the bulk bag.

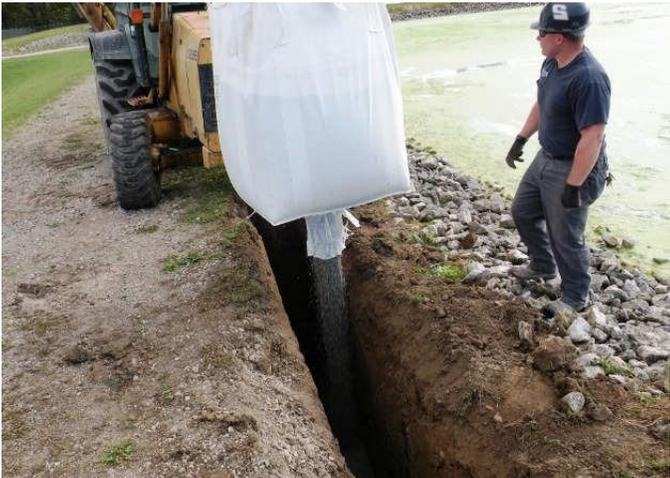
Photo 4. AquaBlok placement from a bulk bag using the same loader/excavator that cut the trench (see Photo 1). Pond at right.

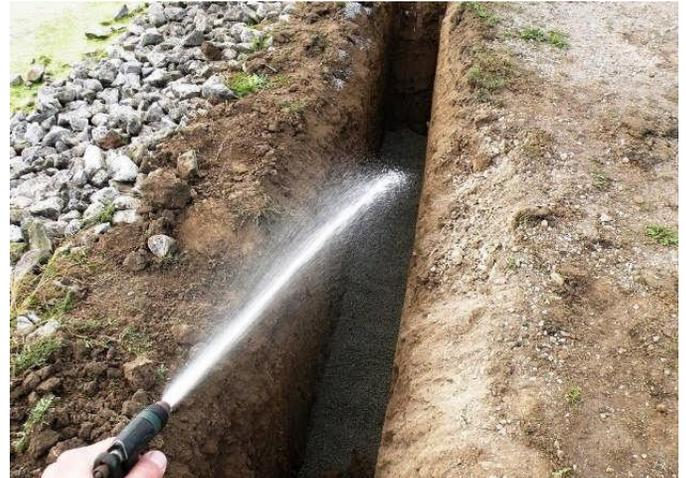
Photo 5. AquaBlok being partially hydrated with a garden hose within an 18" trench (to hold the material in place as the trench length was extended). Pond at left.

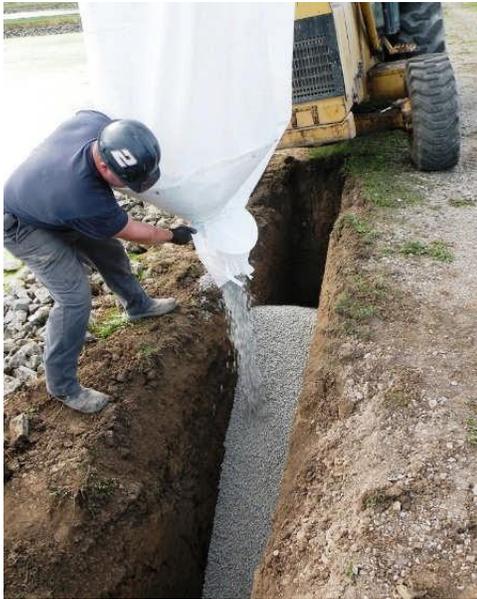
Photo 6. AquaBlok placement from a bulk bag. Note discharge snout directing product into the open trench. Pond at left.

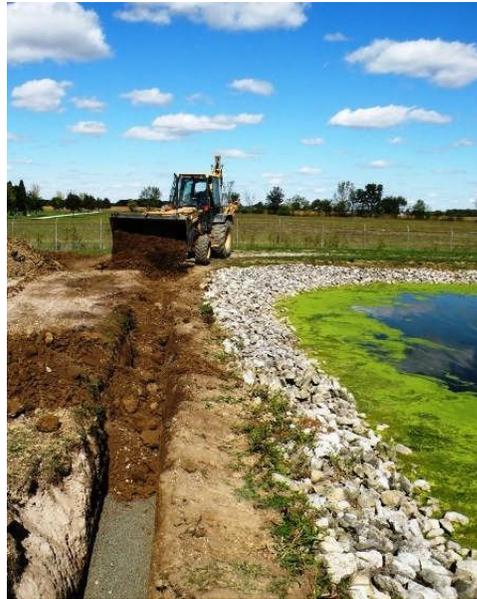
Photo 6. Re-grading of soil, atop the AquaBlok and the designed high water elevation, prior to seeding.

**Results:** Evidence of immediate expansion of the bentonite coating was visually apparent as the material was wetted in the trench. Once the top of the berm was re-graded and seeded, no settling or crowning (associated with bentonite swell) were observed. Visual signs of drainage associated with the seepage (e.g. saturated soils and lush grass on the backside of the dam) were no longer present the following spring, and no changes or signs of water loss have been observed since.
