AquaBlok® Installation Profile

Site Location: *US EPA Region 6*
Arkansas River – Tulsa, OK

Project Status: Completed Fall of 2012

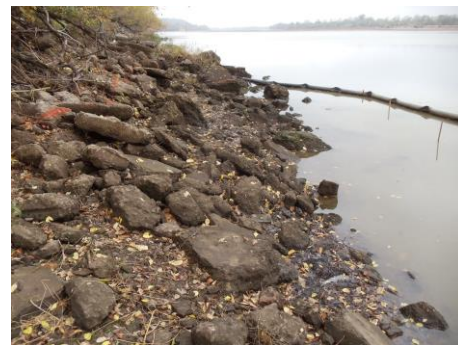
Above – Demo Debris Area - Before

Area A This segment consisted of approximately 1,200 feet of river bank with a steep slope (nearly 1 H :1 V) and a vertical drop from the crest of the slope to the river bank of approximately 30 feet. The river bank is heavily vegetated (estimated 30+ year old trees) and covered with demolition debris consisting of concrete, bricks, pipes, etc. In and amongst the demolition debris acid sludge has been observed in addition to river bank sheening. It was determined that Area A would receive a Horizontal Funnel & Gate capping system that consists of a permeable treatment system. No sub-base preparation would be performed, other than the removal of any woody debris, plants etc. from the shoreline capping area. Following this preparation, the AquaGate+Organoclay permeable treatment material would be placed along the base of the demo debris out into the river approximately 20 feet at an application rate of approximately 7 lb/SF directly over the existing sediment surface at a thickness of approximately 1 inches

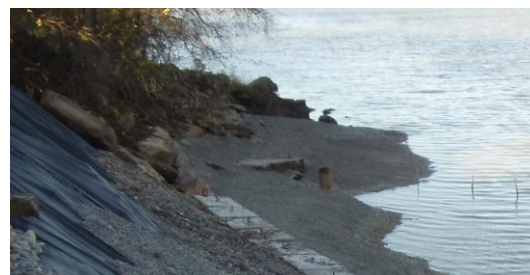
Above – Demo Debris Area - After

(+/- 0.5 inch). After placement of the permeable treatment layer, the low-permeability AquaBlok layer would be placed directly over the AquaGate+Organoclay with the material working back up the shoreline slope. Placement of the AquaBlok continued beyond the organoclay layer up over the existing demo debris. The application rate is estimated to be approximately 40 lb/SF to achieve a nominal 5 inch dry thickness (+/- 1.0 inch), which will swell when hydrated to achieve a final layer thickness greater than 6 inches.

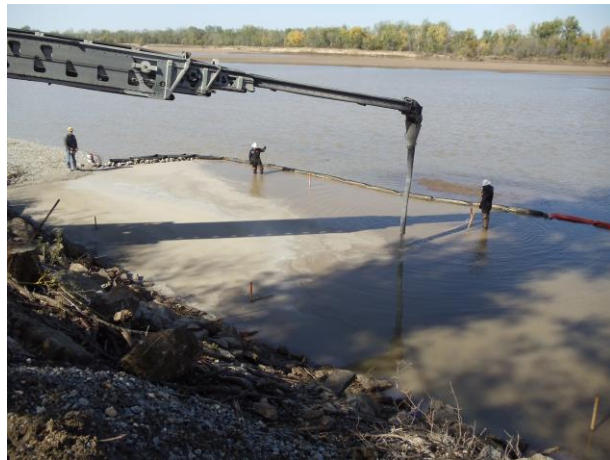
Above – Placement of AquaGate+Organoclay

It was determined that Area B would receive a Horizontal Funnel & Gate capping system of essentially the same construction as Area A above. No sub-base preparation would be performed. AquaGate+Organoclay permeable treatment material was placed along the base of the rip rap zone out into the river approximately 50 feet at an application rate of approximately 7 lb/SF directly over the existing sediment surface at a thickness of approximately 1 inches (+/- 0.5 inch). After placement of the AquaGate, a low-permeability AquaBlok layer was placed directly over the AquaGate with the material working back up the shoreline slope. The application rate is estimated to be approximately 40 lb/SF to achieve a nominal 5 inch dry thickness (+/- 1.0 inch), which will swell when hydrated to achieve a final layer thickness greater than 6 inches.

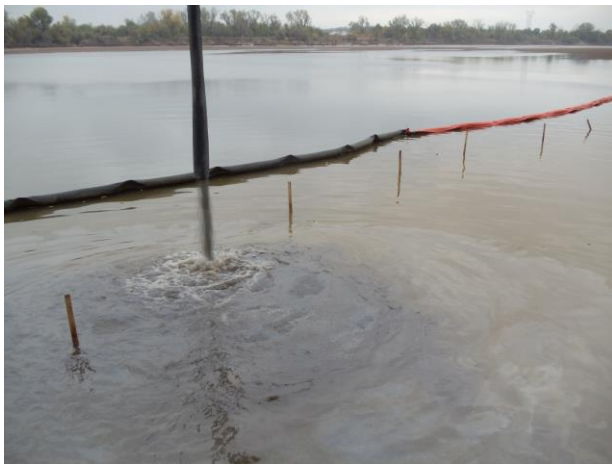
Above – Close-up of Telebelt Material Placement

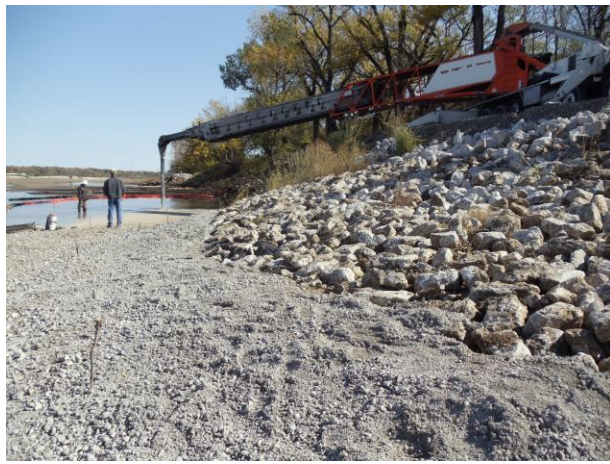
Above – View of Telebelt During Armor Stone Placement

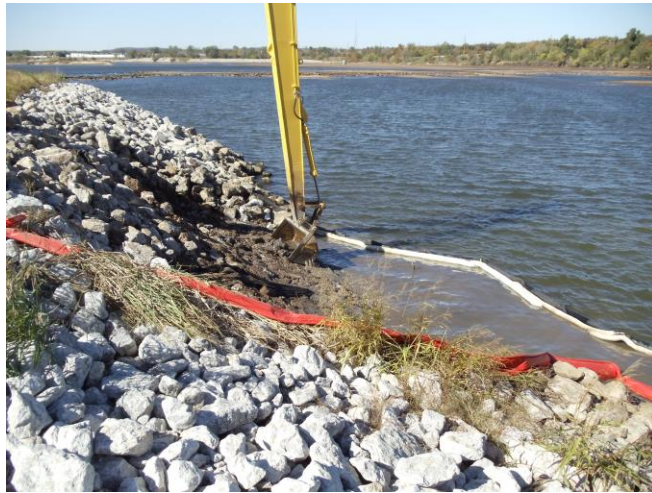
Left – Placement of AquaBlok Over Rip Rap
Below – Using Blower to Distribute AquaBlok

Area C Rip Rap & LNAPL: Approximately 4-5 years ago a remediation project was completed in this area that included a river bank improvement (installation of clay, geotextile, and nominal 12-18 inch rip rap) along approximately 1,300 lineal feet of river bank. It has been determined that this approach failed as the result of observed sheening along a portion of the river bank. Sheening was observed at the toe of the slope and also emanating from the river bed sand approximately 10-20 feet beyond the toe of the slope. Some sheening was observed on the slope amongst the rip rap. This area is open and easily accessible, so it was determined that two approaches would be employed at this location. First, a layer of rip rap was removed and a layer of low permeability AquaBlok was placed along the slope of the shoreline as a means to cut-off seepage through the GCL and existing rip rap. Secondly, an attempt was made to place AquaBlok directly over and between the openings in the rip rap to determine if it would be possible to provide a low permeability barrier to prevent seepage without removal of the rip rap.
